# Holland Home Inspections LLC.

## Home Inspection Report

**123 Example st**

Inspected on Thu, Aug 1 2024 at 8:00 AM

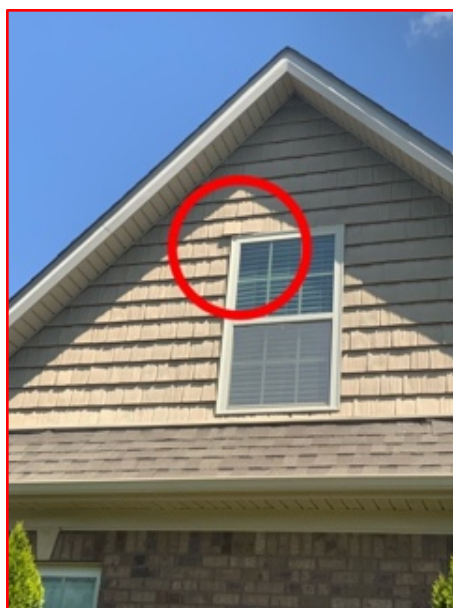
Figure 1-1

1) During inspection of the exterior a loose piece of vinyl siding was observed on the front gable above a window. Recommend a qualified individual to repair.

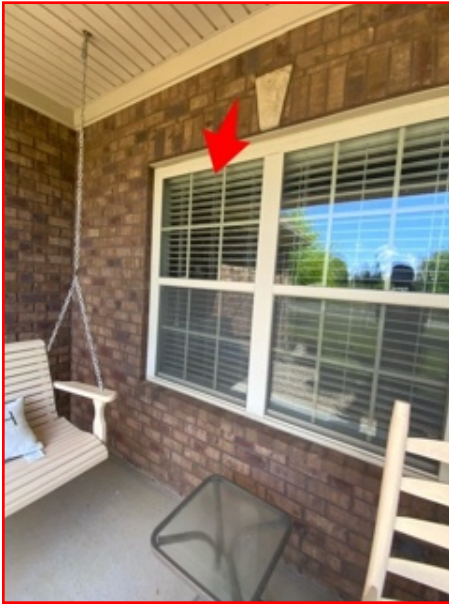
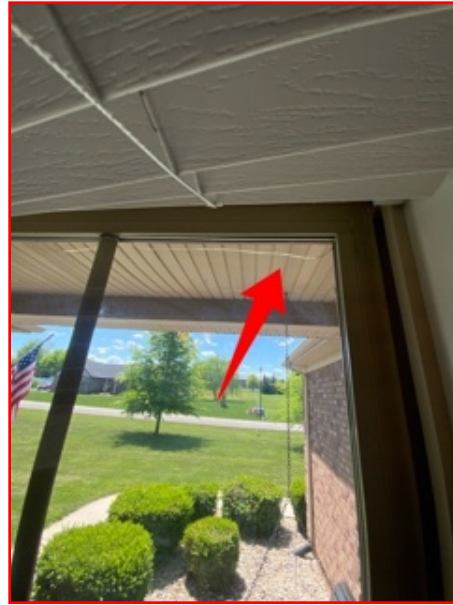
2) An exterior window located on the front of the house has a broken glass in the upper portion. This is a double glass pane window with the exterior glass pane broken. Recommend repair by a qualified individual.

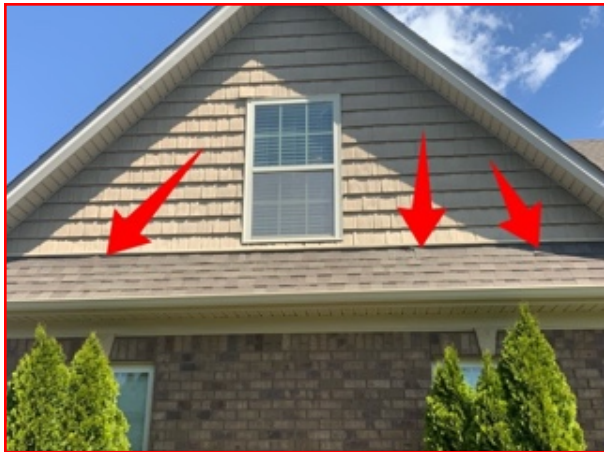
Figure 3-1

3) During inspection the shingled roof covering at the front of the house damaged or loose shingles was observed. This is on a portion of the roof that extends out from the gable end. Recommend further evaluation by qualified individual for repair.

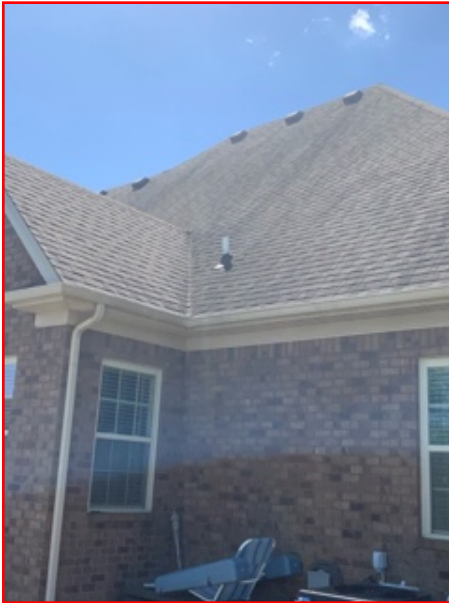
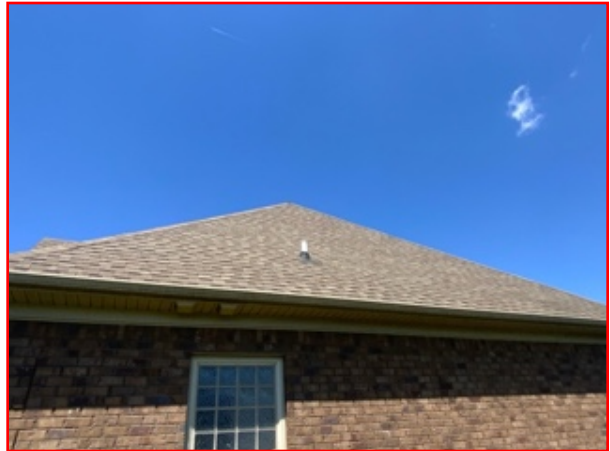
4) During inspection of the plumbing vent that penetrates the roof has the test cap is still installed. Test caps are installed during the plumbing installation and pressure testing. Recommend removal of the test cap before occupancy by a qualified individual.

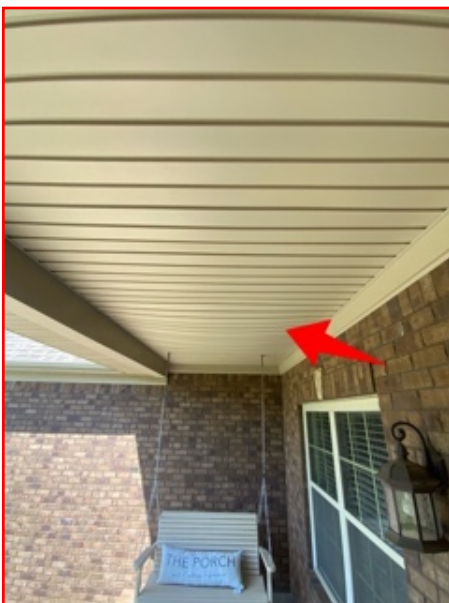
Figure 5-1

5) During inspection of the vinyl soffit for the front porch it appears the soffit is loose and sagging. Recommend a qualified individual to repair as needed.

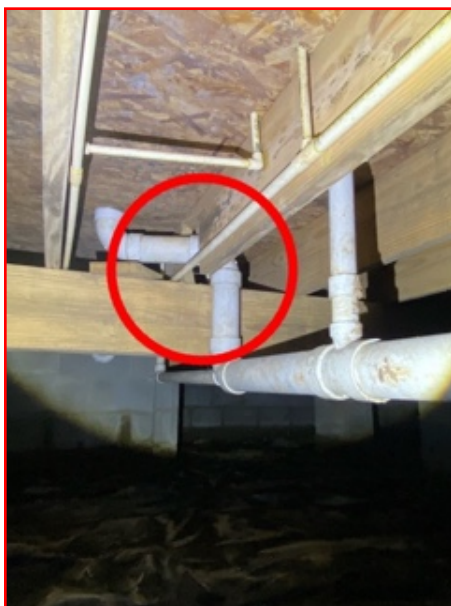
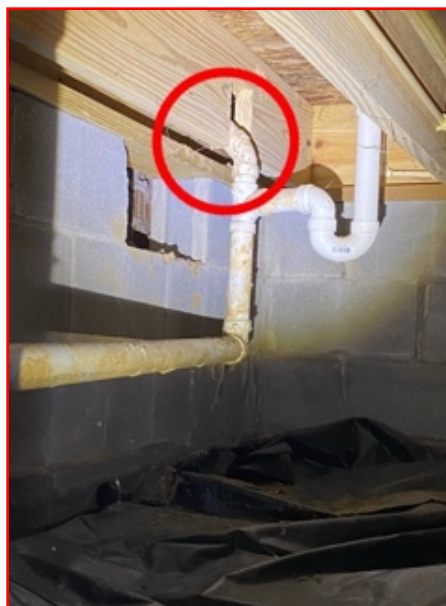
6) During inspection of the floor joists from the crawl space an over notched floor joist was observed in two locations . The floor joist appears to be over notched to accommodate plumbing for the master and hall bathroom. Over notched floor joist are not as structurally sound as floor joist that are not notched. Recommend further evaluation by qualified individual for solutions for repair.

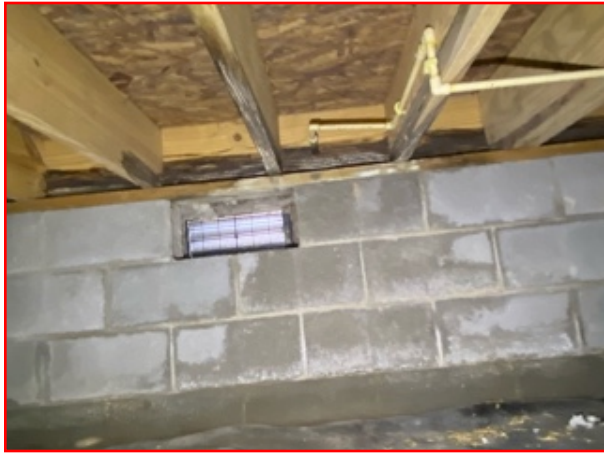
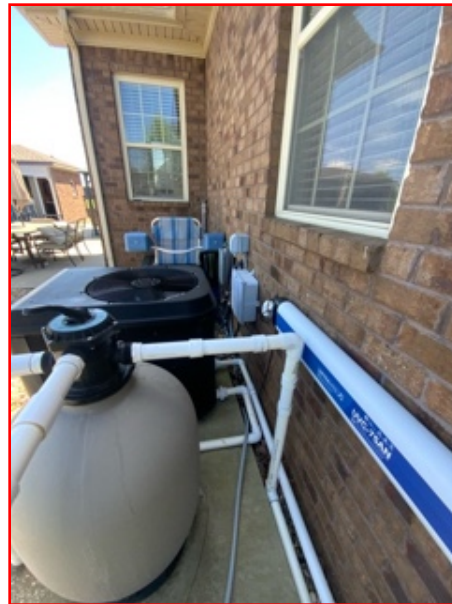
7) During inspection of the wood floor structure from the crawl space moisture staining was observed on the rim board at the rear of the house. This is in proximity to the pool pump/filter system. This condition can occur when moisture in the area wicks through the brick to the wood framing. Recommend further evaluation by qualified individual for sources of moisture and solutions of repair.

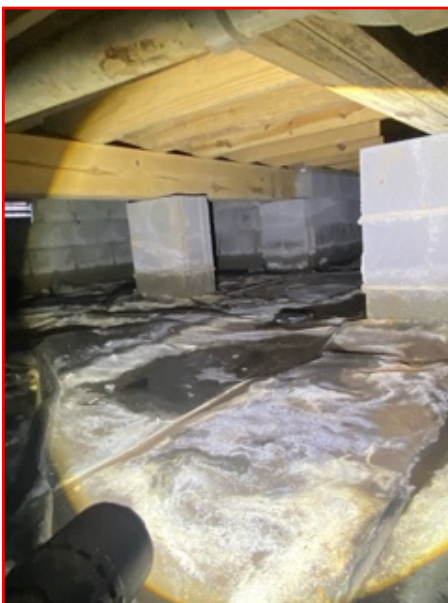
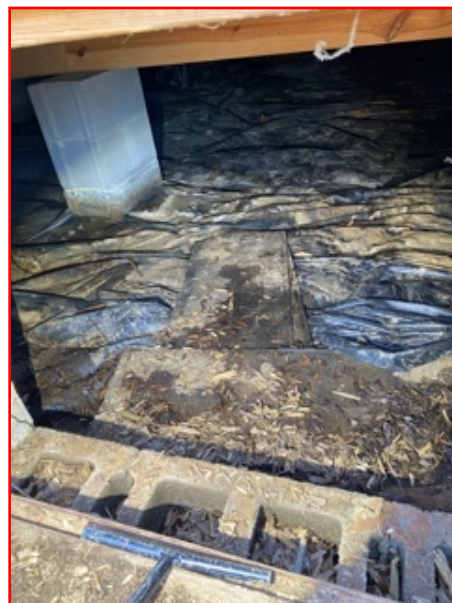
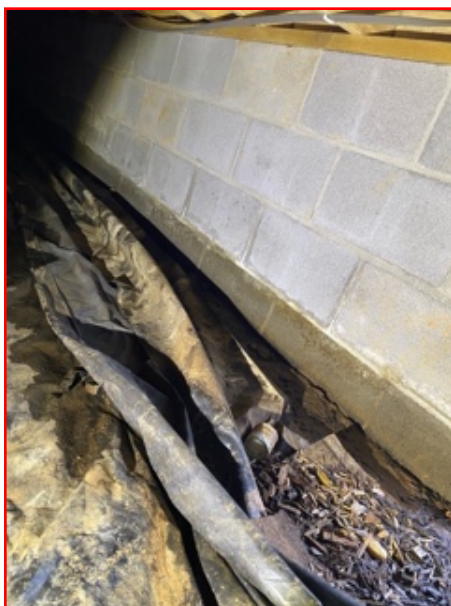
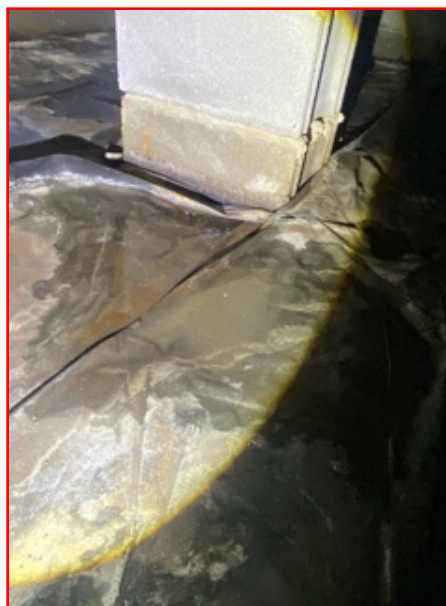
8) During inspection of the crawlspace standing water as well as moisture staining was observed. This condition can be the result of clogged underground gutter downspouts, poor grading or a high water table for the area. Moisture in the crawlspace can result in a biological growth and deterioration of the wood floor structure as well as deterioration of the foundation materials. Recommend further evaluation by qualified individual for solutions of repair.

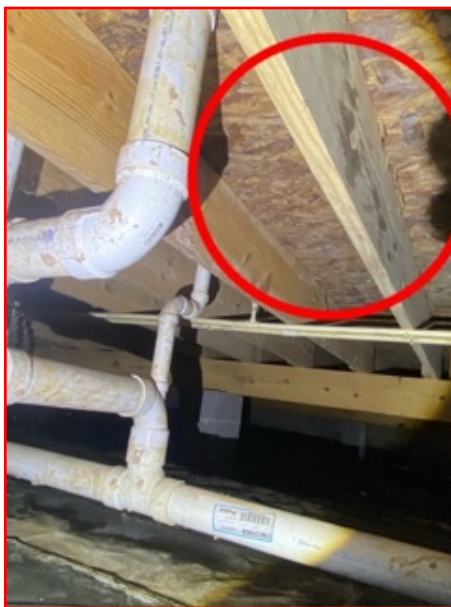
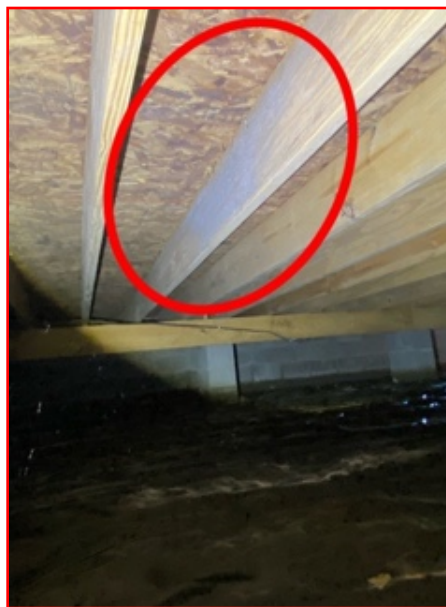
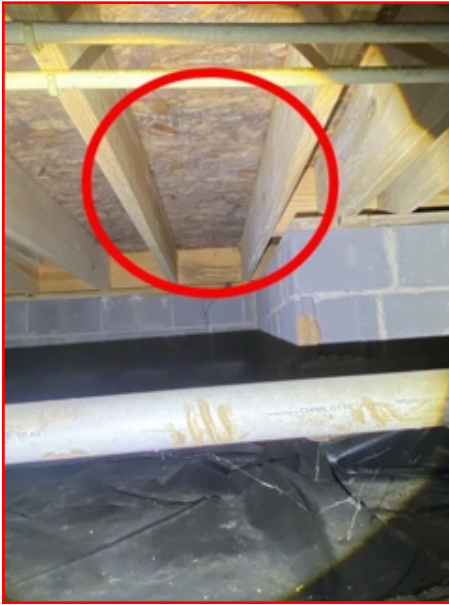
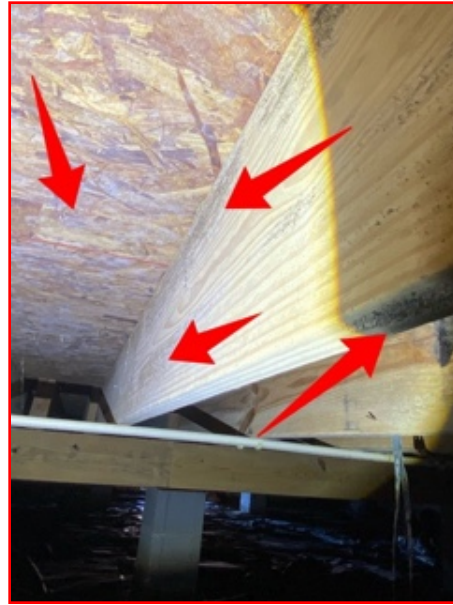
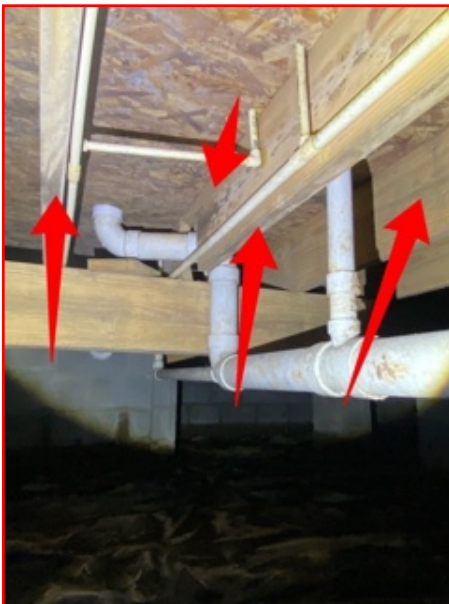
9) During inspection of the crawl space a biological growth was observed on the wood floor structure in various locations . This condition is often a result of moisture in the crawl space as well as poor ventilation. The leaking plumbing and ground moisture can allow this condition to occur. It is recommend that a qualified individual evaluation and repair or mitigate as need.

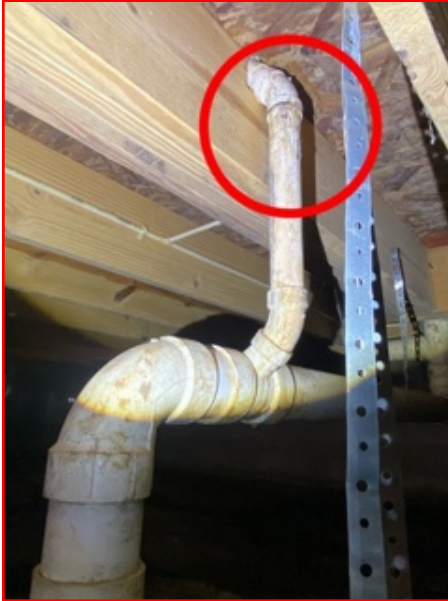
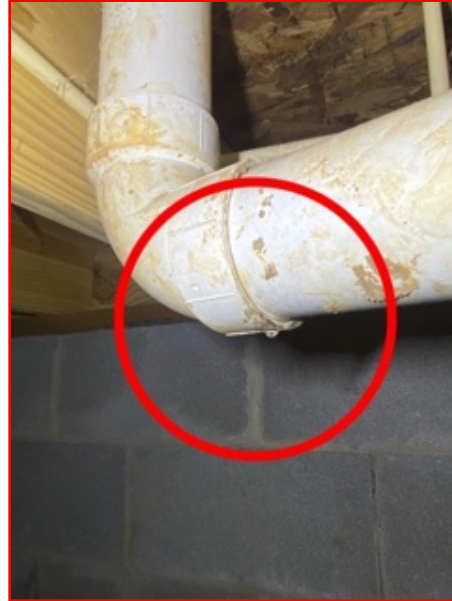
10) During inspection of the hall bath room plumbing from the crawl space a leak was visible. This condition appears to be where the vanity sink drain is as well as the toilet drain at a fitting. Recommend a qualified individual to evaluate and repair as needed.

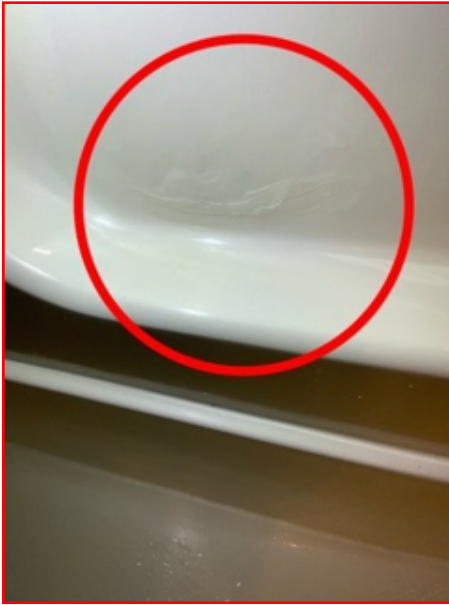
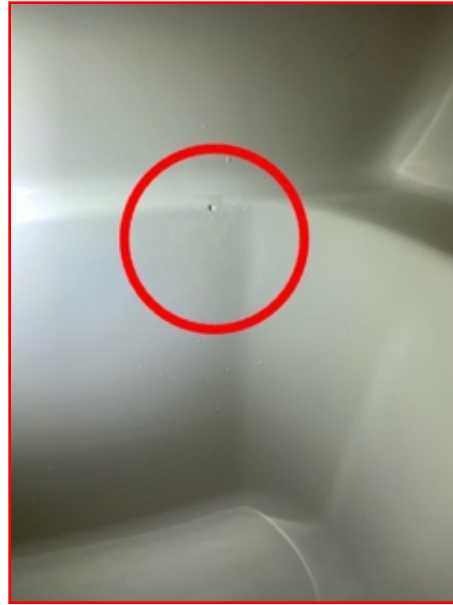
11) During inspection of the hall bathroom signs of a repaired crack in the fiberglass tub surround was observed. It appears the repair was made with a flexible sealant. This type of repair is temporary. Recommend a qualified individual to evaluate for a permanent repair.

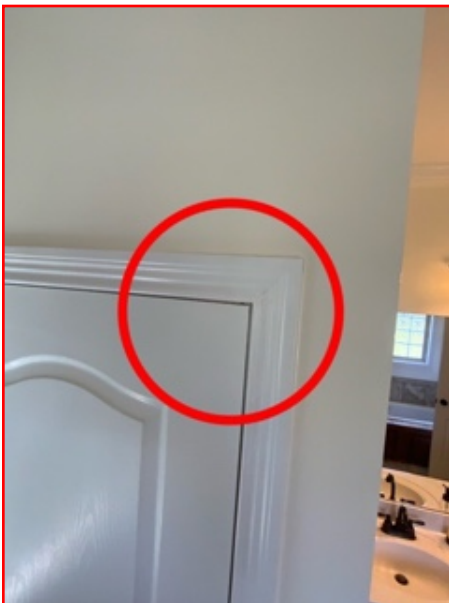
Figure 13-1

12) The wood interior door for the master bathroom does not close properly. Recommend further evaluation by a qualified individual for adjustment or solutions of repair.

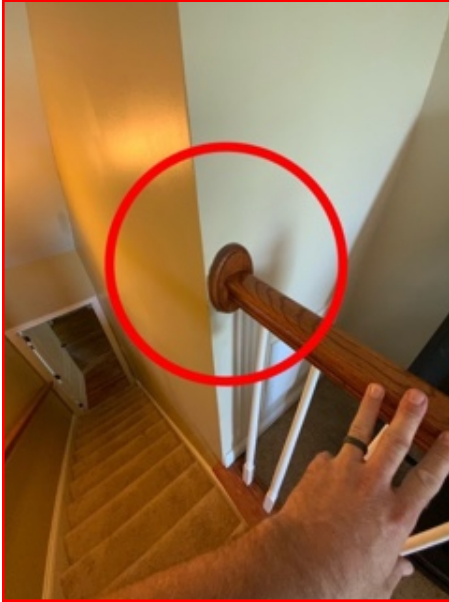
Figure 14-1

13) The bonus room stairs has a loose handrail. Recommend repair by a qualified individual.

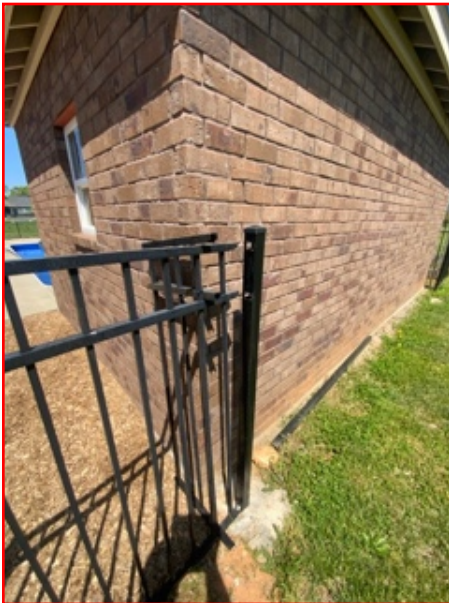
Figure 15-1

14) During inspection the fencing around the pool area is damaged in proximity to the pool house. Recommend repair by a qualified individual.

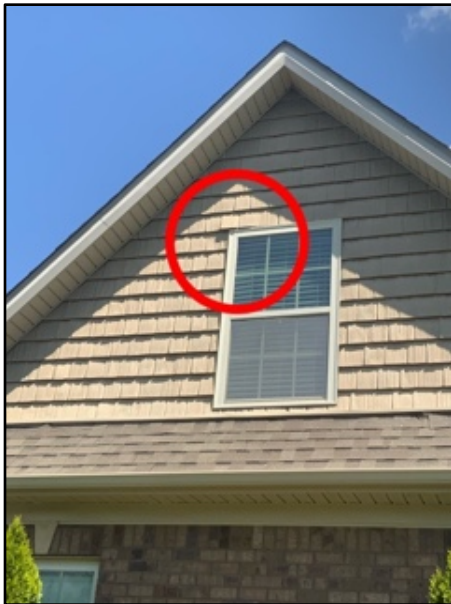
Figure 1-1

During inspection of the exterior a loose piece of vinyl siding was observed on the front gable above a window. Recommend a qualified individual to repair.

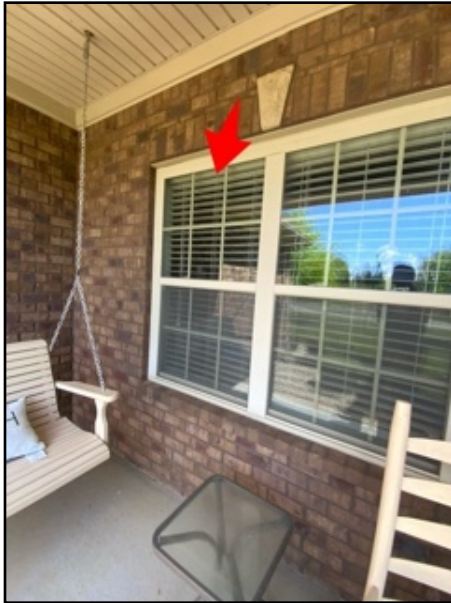
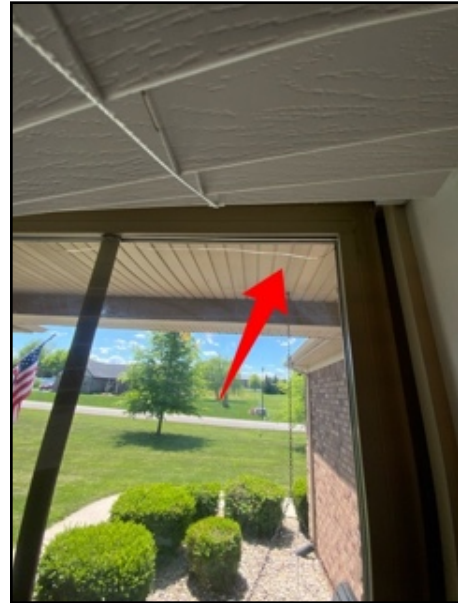
An exterior window located on the front of the house has a broken glass in the upper portion. This is a double glass pane window with the exterior glass pane broken. Recommend repair by a qualified individual.

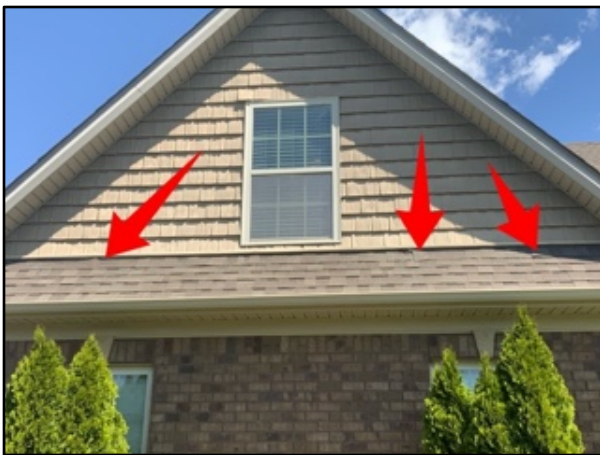
Figure 3-1

**Comment 3:**  
During inspection the shingled roof covering at the front of the house damaged or loose shingles was observed. This is on a portion of the roof that extends out from the gable end. Recommend further evaluation by qualified individual for repair.

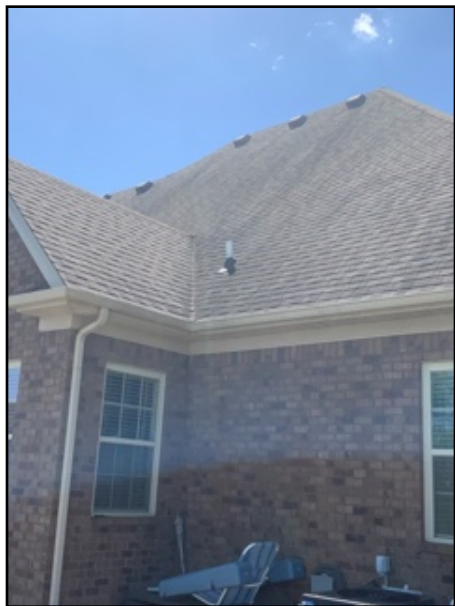
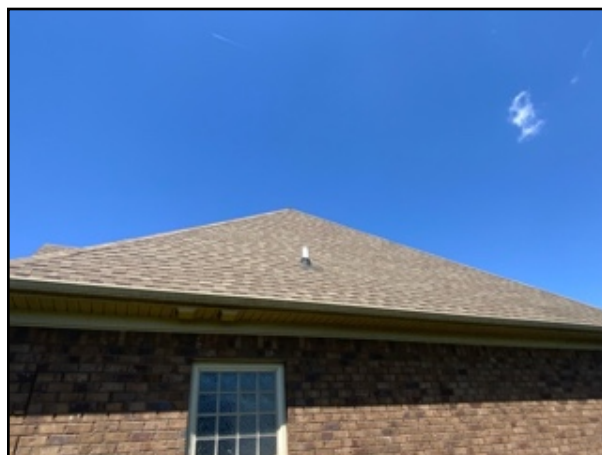
During inspection of the plumbing vent that penetrates the roof has the test cap is still installed. Test caps are installed during the plumbing installation and pressure testing. Recommend removal of the test cap before occupancy by a qualified individual.

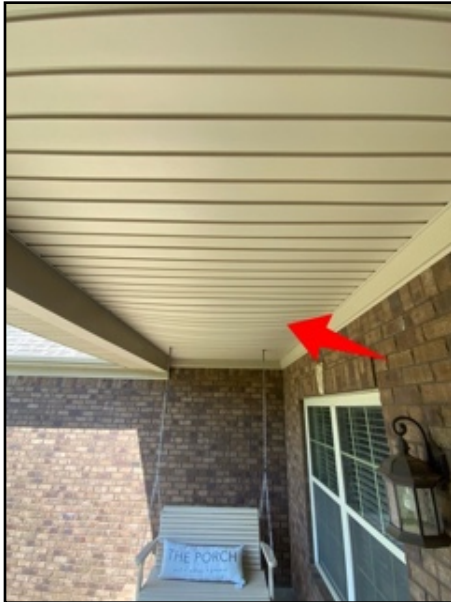
Figure 5-1

During inspection of the vinyl soffit for the front porch it appears the soffit is loose and sagging. Recommend a qualified individual to repair as needed.

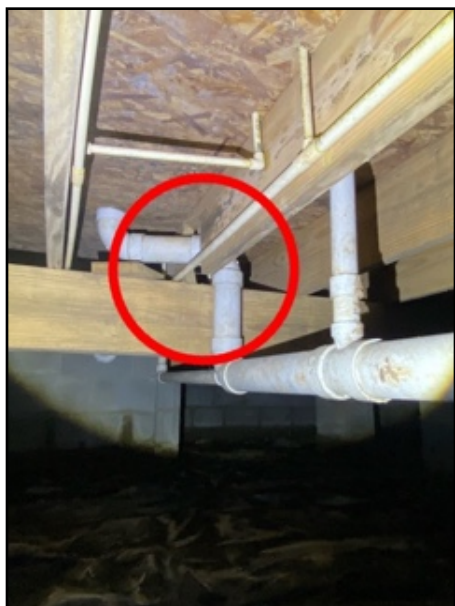
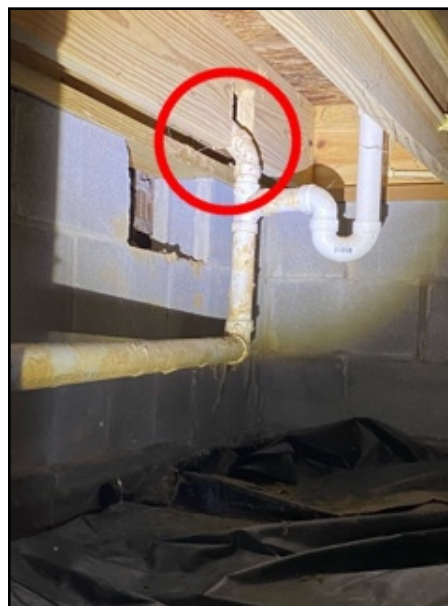
During inspection of the floor joists from the crawl space an over notched floor joist was observed in two locations . The floor joist appears to be over notched to accommodate plumbing for the master and hall bathroom. Over notched floor joist are not as structurally sound as floor joist that are not notched. Recommend further evaluation by qualified individual for solutions for repair.

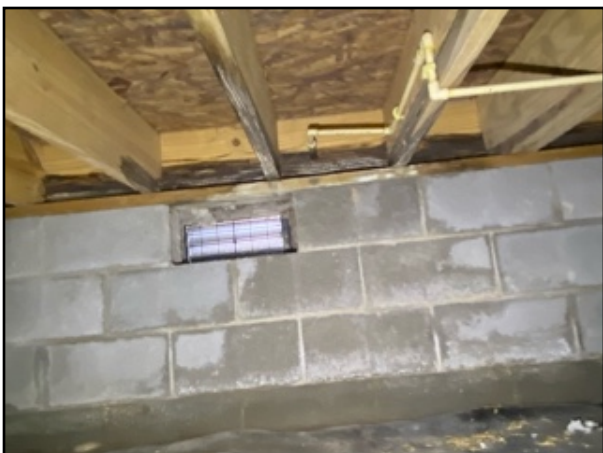
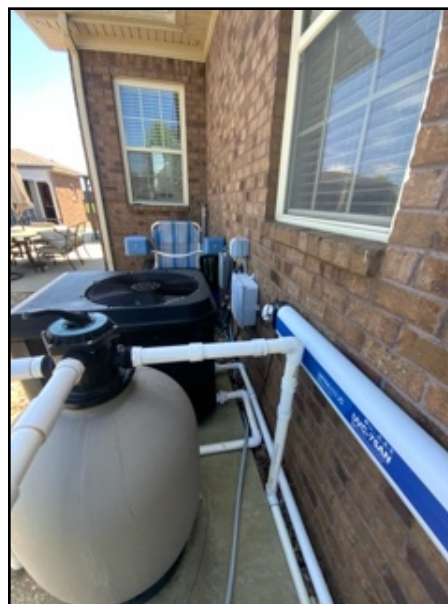
During inspection of the wood floor structure from the crawl space moisture staining was observed on the rim board at the rear of the house. This is in proximity to the pool pump/filter system. This condition can occur when moisture in the area wicks through the brick to the wood framing. Recommend further evaluation by qualified individual for sources of moisture and solutions of repair.

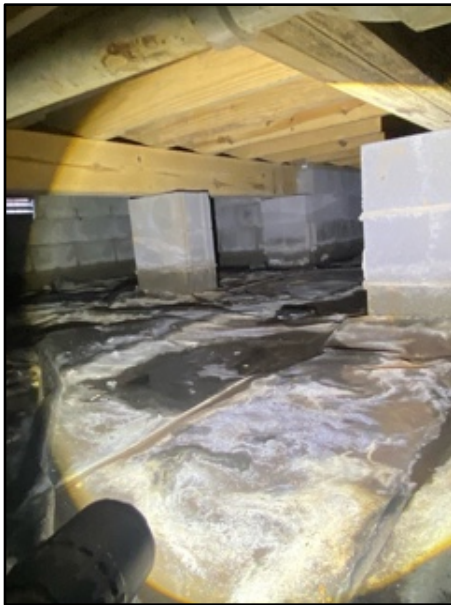
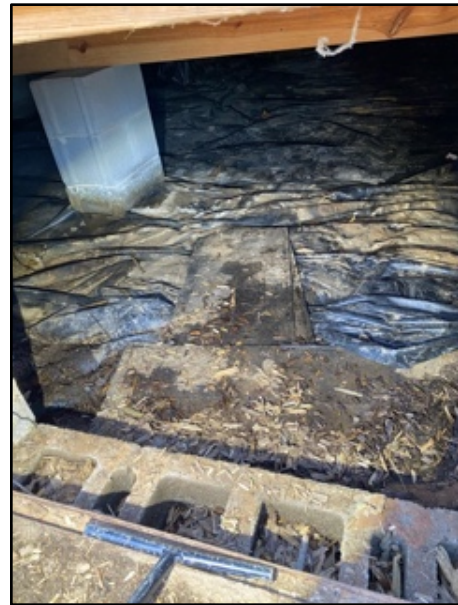
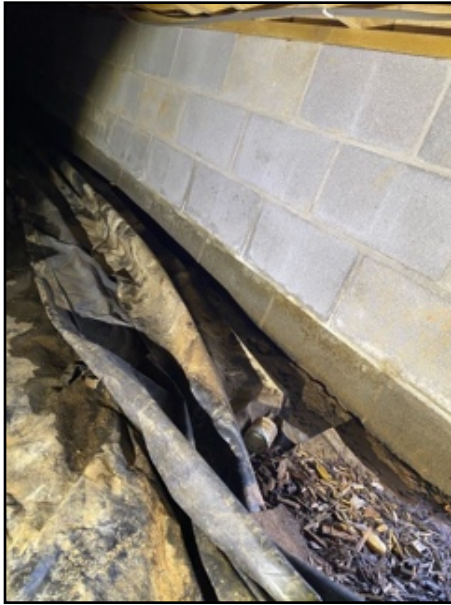
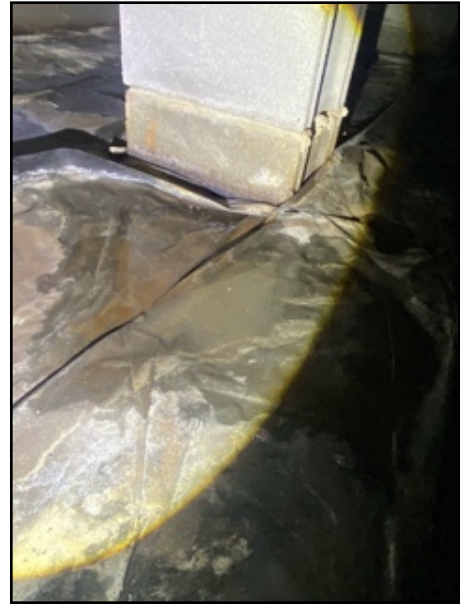
During inspection of the crawl space standing water as well as moisture staining was observed. This condition can be the result of clogged underground gutter downspouts, poor grading or a high water table for the area. Moisture in the crawl space can result in a biological growth and deterioration of the wood floor structure as well as deterioration of the foundation materials. Recommend further evaluation by qualified individual for solutions of repair.

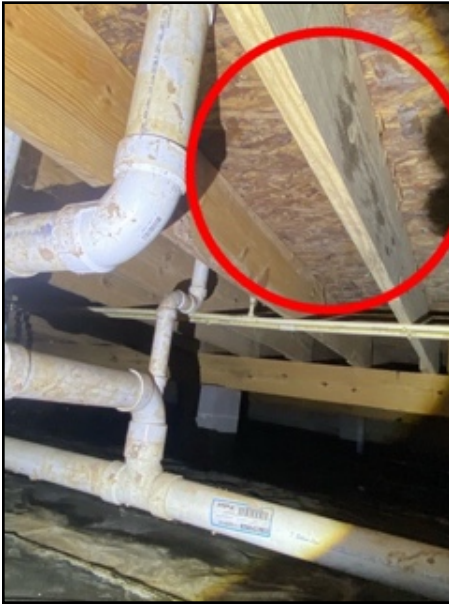
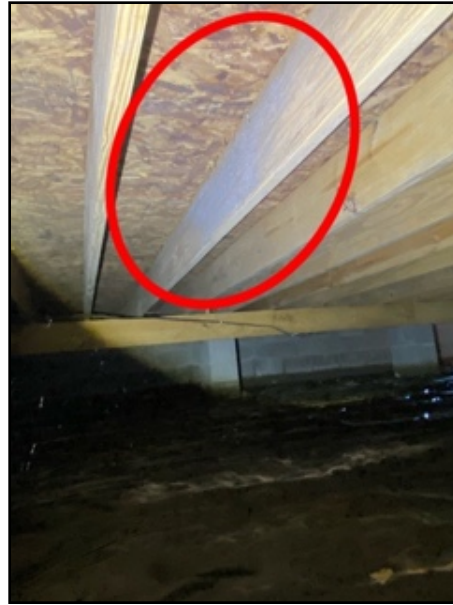
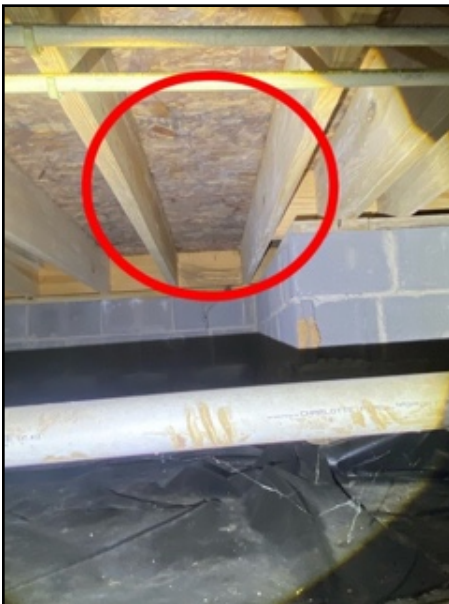
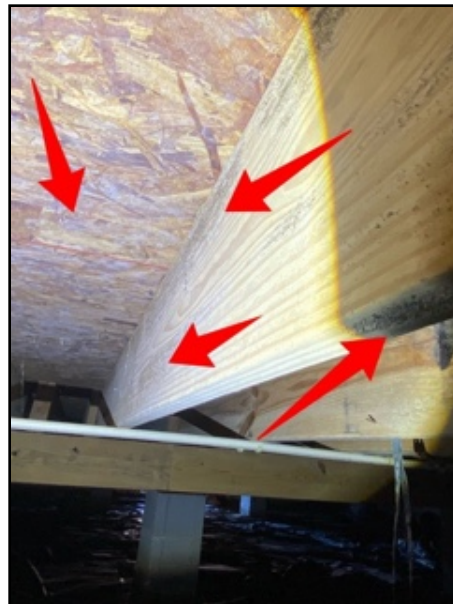
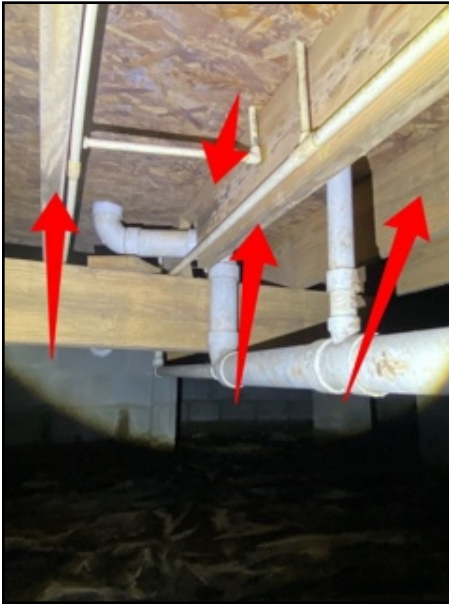
During inspection of the crawl space a biological growth was observed on the wood floor structure in various locations . This condition is often a result of moisture in the crawl space as well as poor ventilation. The leaking plumbing and ground moisture can allow this condition to occur. It is recommend that a qualified individual evaluation and repair or mitigate as need.

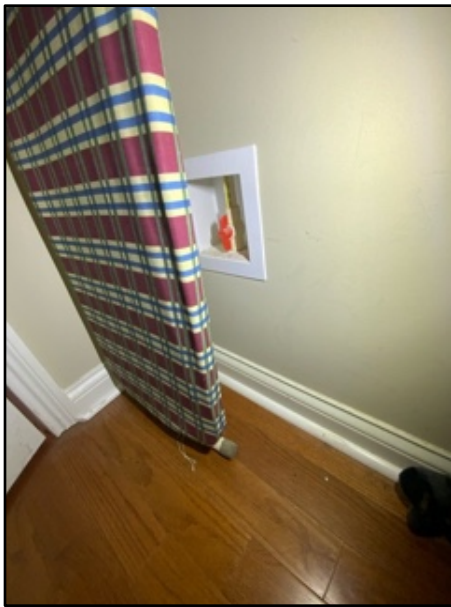
Figure 10-1

Comment 10:  
Main water shut off is located in the master bedroom closet.

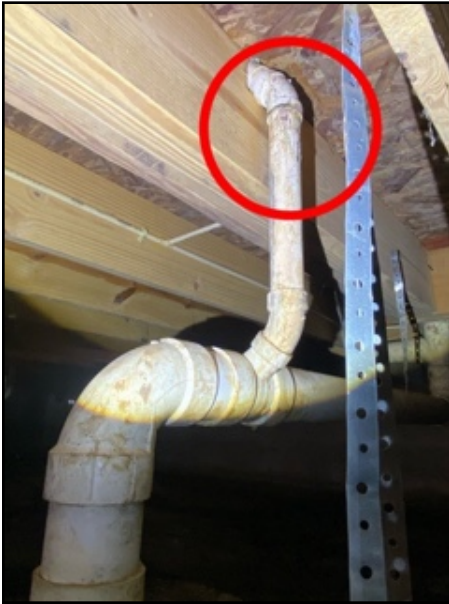
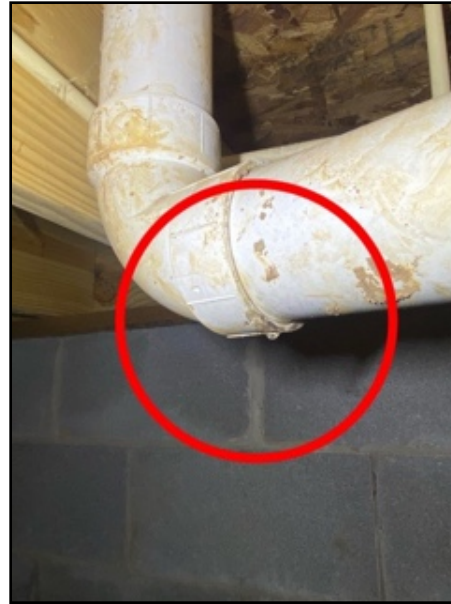
During inspection of the hall bath room plumbing from the crawl space a leak was visible. This condition appears to be where the vanity sink drain is as well as the toilet drain at a fitting. Recommend a qualified individual to evaluate and repair as needed.

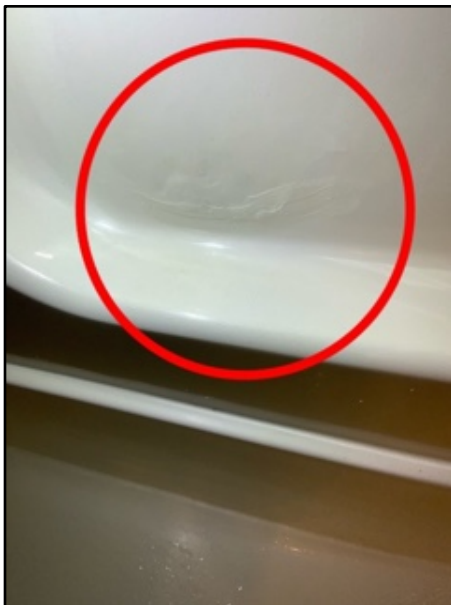
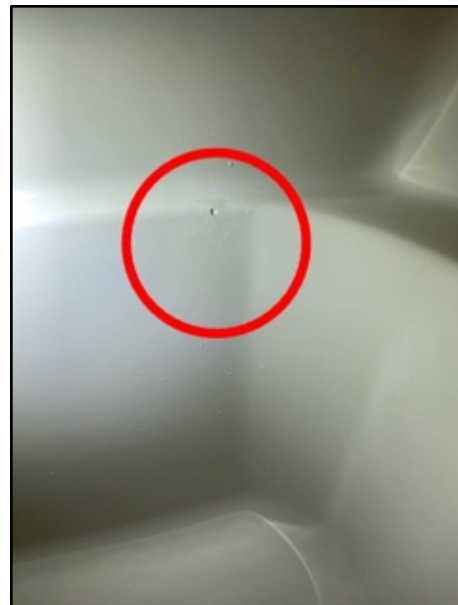
During inspection of the hall bathroom signs of a repaired crack in the fiberglass tub surround was observed. It appears the repair was made with a flexible sealant. This type of repair is temporary. Recommend a qualified individual to evaluate for a permanent repair.

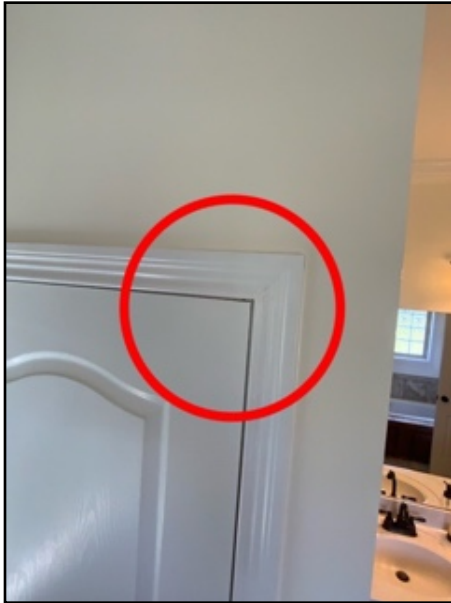
Figure 13-1

The wood interior door for the master bathroom does not close properly. Recommend further evaluation by a qualified individual for adjustment or solutions of repair.

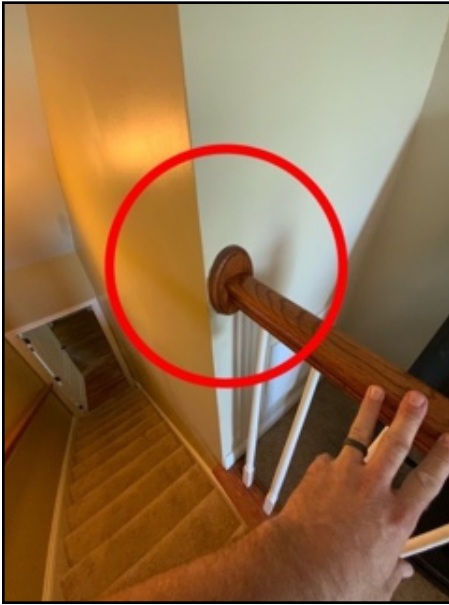
Figure 14-1

The bonus room stairs has a loose handrail. Recommend repair by a qualified individual.

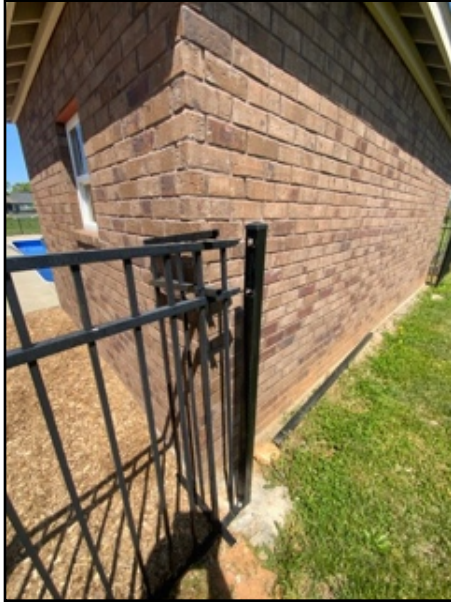
Figure 15-1

During inspection the fencing around the pool area is damaged in proximity to the pool house. Recommend repair by a qualified individual.
